**Teledyne Continental Motors, Inc.**  
A Teledyne Technologies Company

## Magneto Analysis Report

Date Received:	02-25-2011	Analytical Date:	03-02-2011			
Warranty Claim #:	N/A	RGA #:	00.113.487			
Engine Model:	IO-320-C1A	Engine Serial #:	L-4277-55A			
Aircraft Make/Model:	Piper PA-30	Aircraft S/N:	30-1931	Reg. #:	N64RJ	
Engine Position:	Single:	Left:	Right:	X	Front:	Rear:
Engine Build Date:	Unknown	Date in Service:	Unknown	Date Removed:	Unknown	
Date of Occurrence:	01-30-2011	Magneto Hours:	Unknown			
Components Returned:	Magneto, Harness and Noise Filter					
Returned By:	Patrick Jones-NSTB					
Magneto Model/P/Ns:	10-51360-37	Magneto S/Ns:	1000453			
Component Detail						
Description	Part Number	Serial/Date Code	Description	Part Number	Serial/Date Code	
Contact points	AB-357174		Retard\Tach points	N/A		
Capacitor AB-5167	6	99-11	Coil	10-357164 A		
Distributor block	AB-357424		Magnet, rotating	2		
Contact condition: Normal operating signatures.						
Retard\Tach points condition: Normal operating signatures.

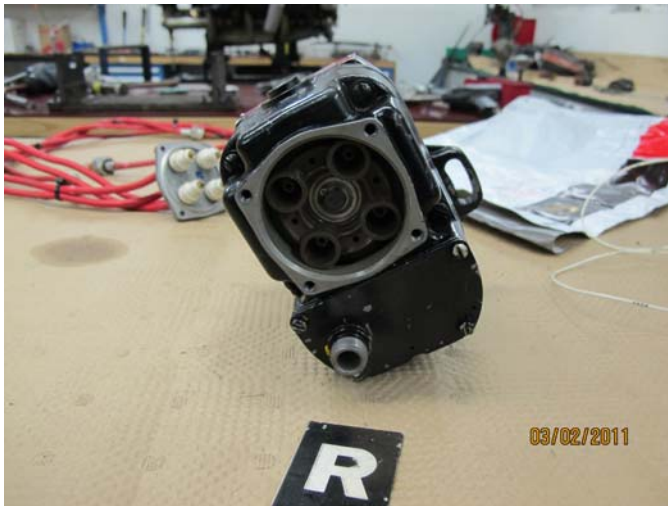
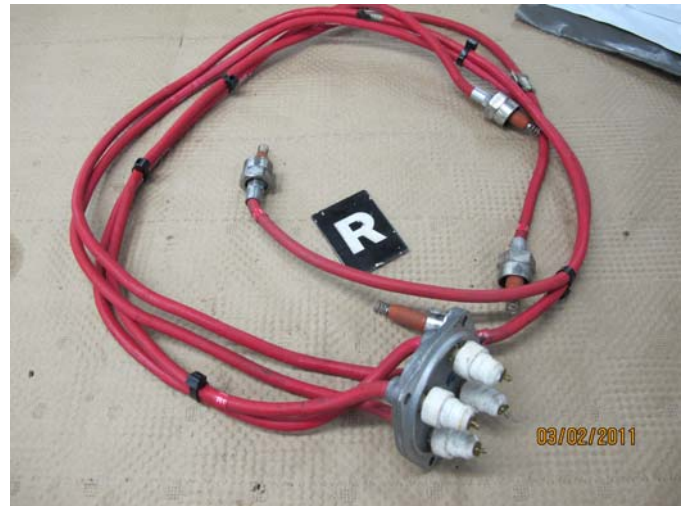
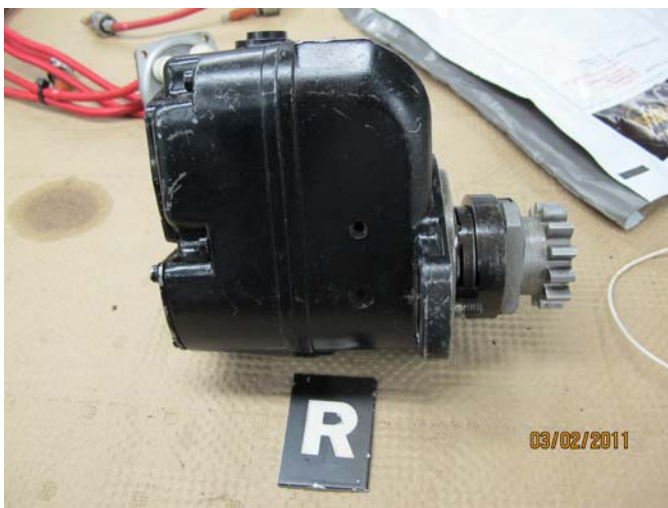
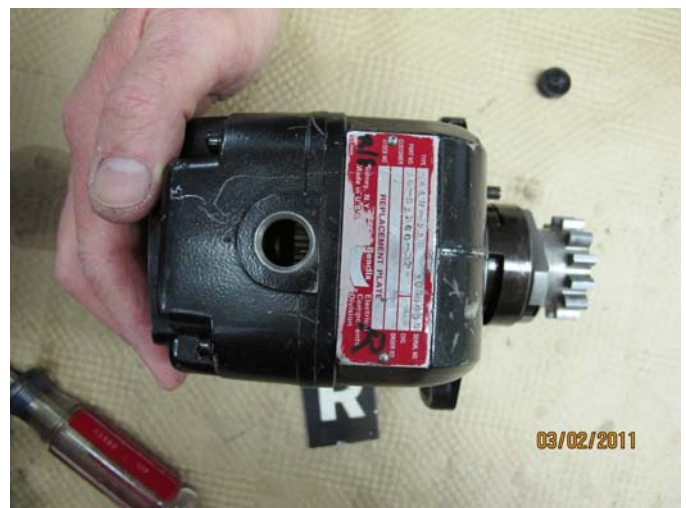
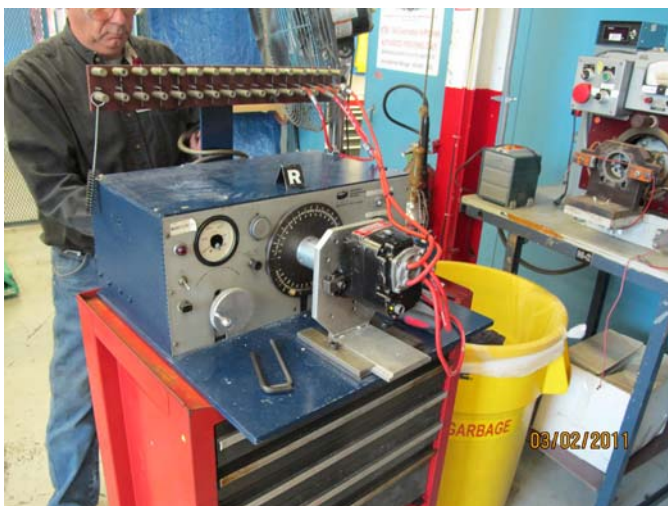
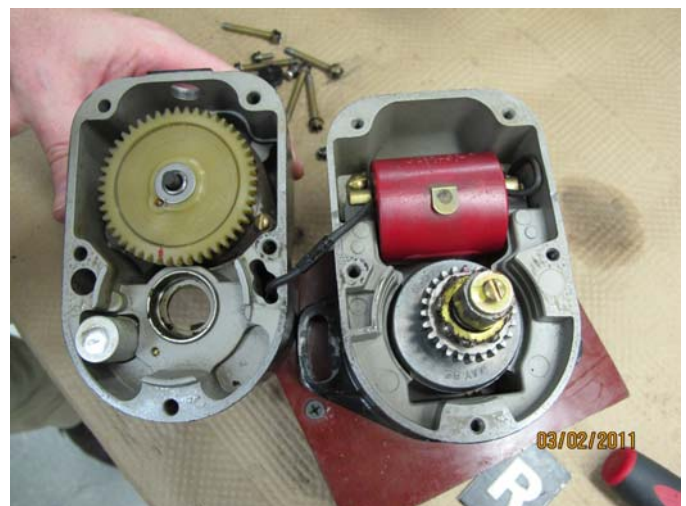
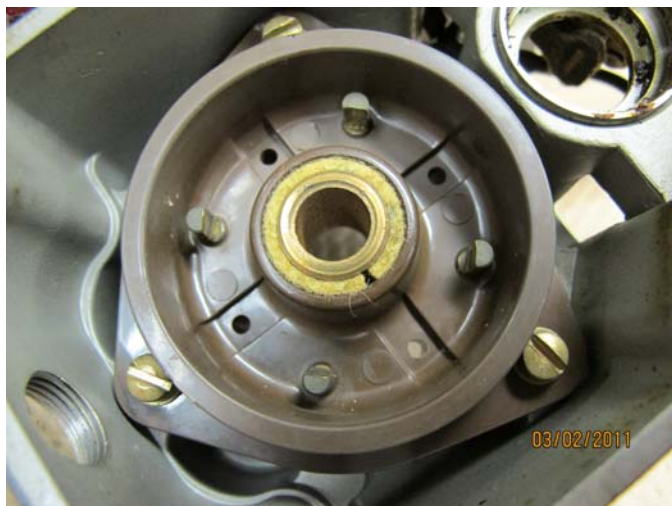
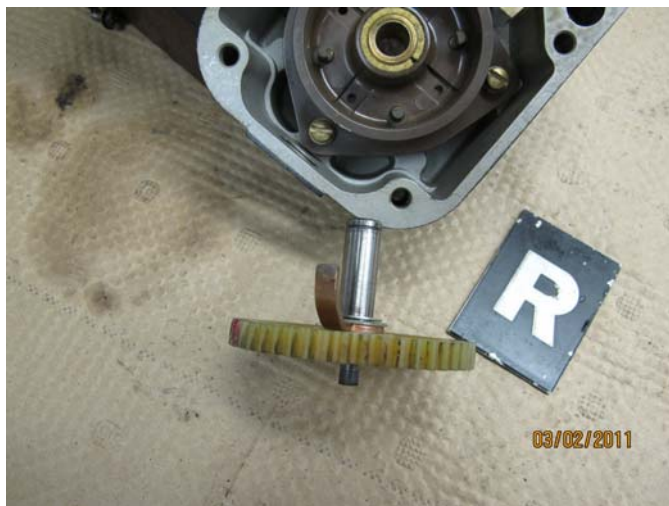
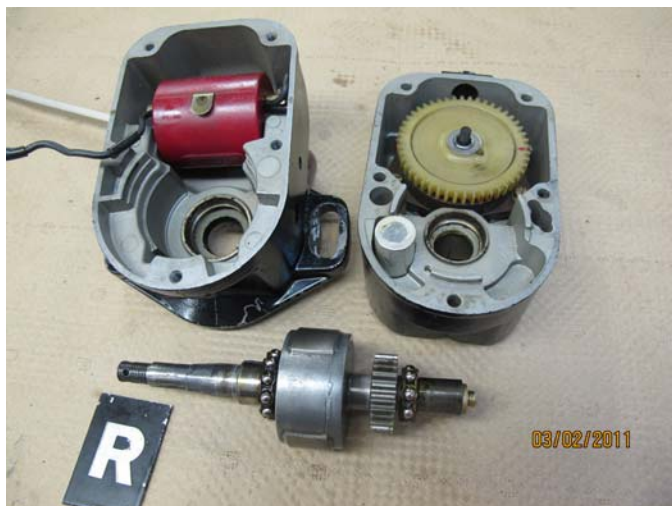
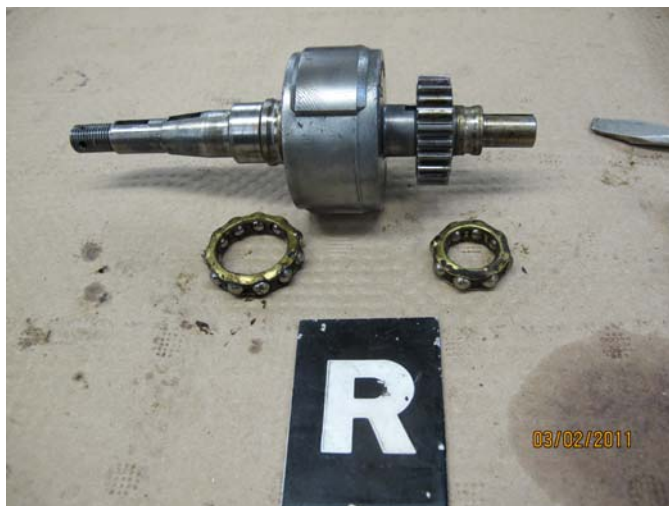
Capacitor condition: Normal operating signatures.						
Coil condition: Normal operating signatures.						
Distributor block condition: Normal operating signatures.						
Magnet, rotating condition: Normal operating signatures.						
Party to the Inspection:	Mike Huhn-NTSB					
Party to the Inspection:	Tim Davis-TCM					
Party to the Inspection:	Andrew Swick-TCM					
Party to the Inspection:	Johnny Little-TCM					
Party to the Inspection:	Greg Eastburn-TCM					
Reason for Return:	Accident Investigation					
Analytical Report:						
Inspection Performed By:	Tim Davis-TCM	Search Code:
